NASA Concrete Paving Stone Evaluation

**Summary of Tests at
NASA - Aircraft Landing Dynamics Facility ALDF
Langley, Virginia**

Friction Evaluation of Concrete Paver Blocks for Airport Pavement Applications

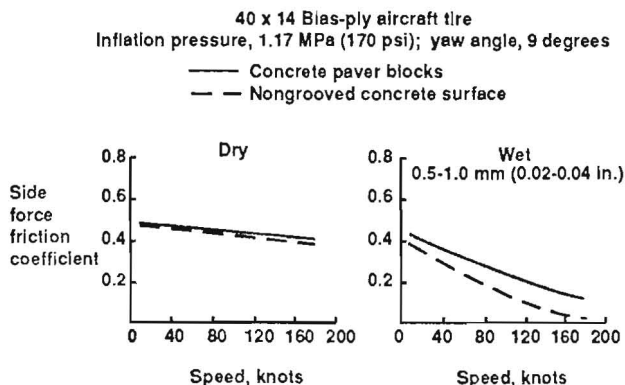
Figure 10. Tire cornering performance with yaw angle.

The initial design, hexagonal-shaped, radial six-grooved, concrete paver block produced some promising wet friction performance results when compared to the nongrooved concrete surface. Figure 10 shows comparative dry and wet steering friction performance variation with speed on the hexagonal-shaped paver block and the nongrooved concrete surfaces obtained with the bias-ply 40 x 14 tire constrained to a 9 degree yaw angle.

These curves were derived from other data plots of side force friction variation with yaw angle at different speed increments. For dry conditions, the steering performance was similar for both test surfaces evaluated, but under wet conditions, the hexagonal-shaped paver block surface produced higher steering friction throughout the speed range tested.

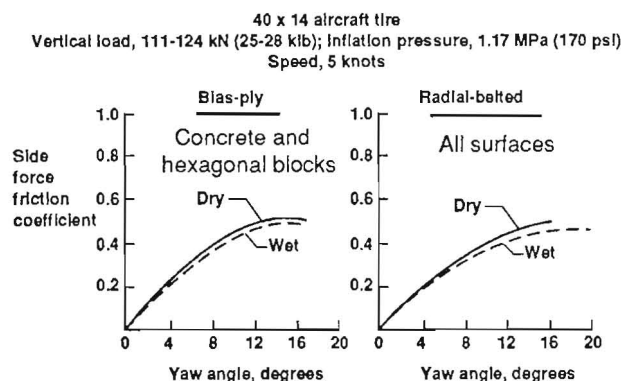
Figure 11. Tire cornering performance with yaw angle.

Figure 11 shows some comparative low speed (5 kt) dry and wet cornering friction performance variation with yaw angle for the radial-belted and bias-ply 40 x 14 tires operating on the nongrooved concrete, the hexagonal-shaped pavers, and the Uni-Anchorlock paver test surfaces. This bias-ply tire has not been tested yet on the Uni-Anchorlock paver blocks.

At this low speed, type of tire, test surface configuration, and wetness condition did not significantly affect the tire cornering friction performance. The radial-belted tire data indicate that peak cornering at this low speed is reached at a higher yaw angle than the bias-ply tire. Additional test runs at the ALDF are planned to confirm these data trends and references 8 and 9 contain other tire friction performance data collected in the START program.

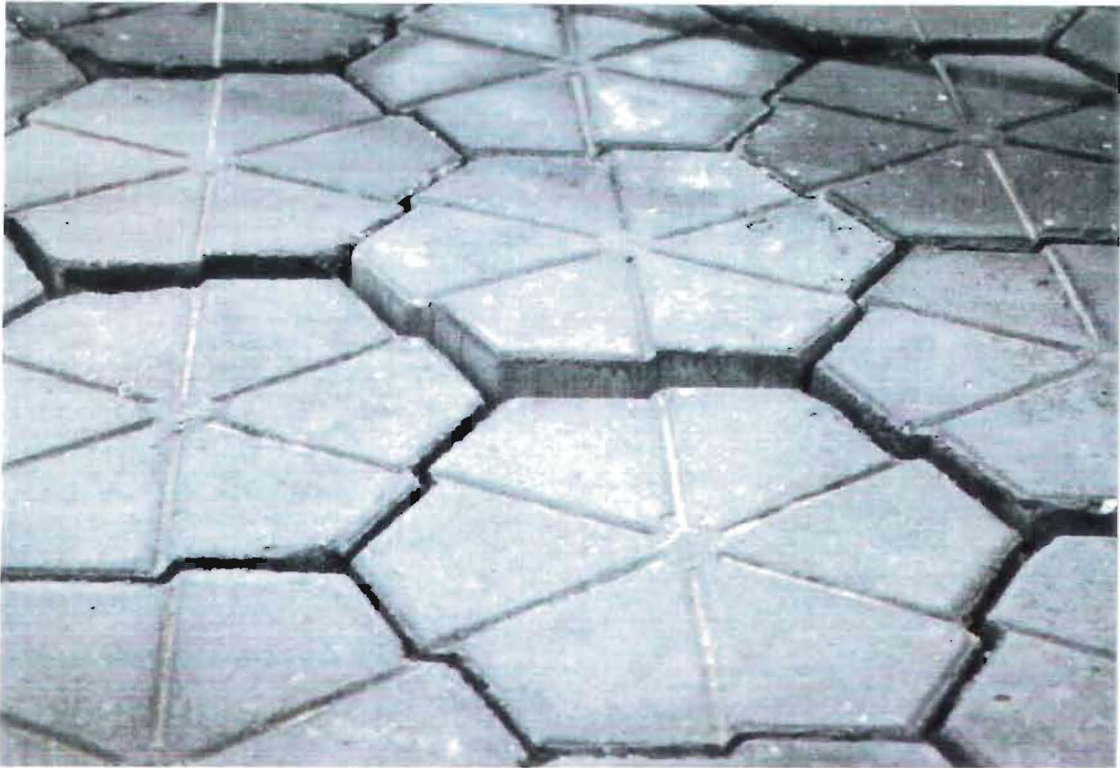
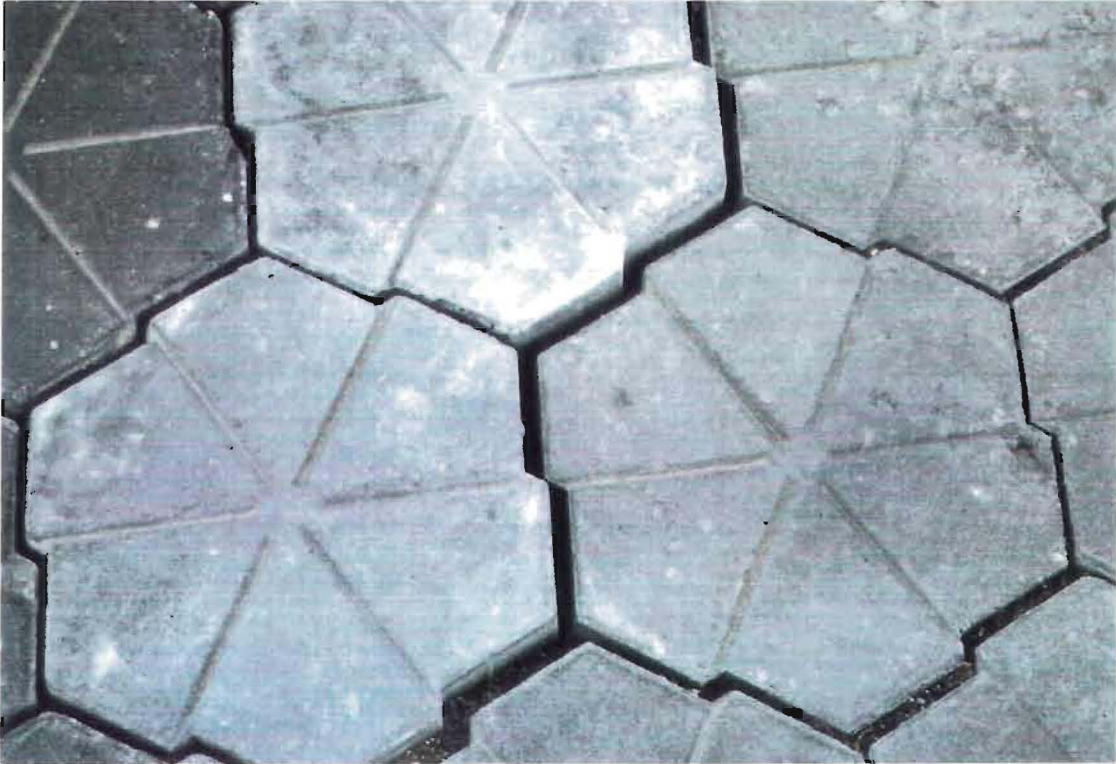
Failing Hexagonal Paver

NASA Test Overview		
Section Parameters	Friction Results	Pavement Stability and Integrity Results
Installed Hexagonal Paver (10 cm), Nov. 1991	satisfactory*	Hexagonal Section Failed
Installed UNI-ANCHORLOCK® (8 cm) Tests Section, May 1992	satisfactory*	UNI-ANCHORLOCK® Section Succeeded
Replaced Hexagonal Paver with 10 cm Multiweave Paver (copy of old UNI-STONE®), August 1993	satisfactory*	Multiweave Paver Section Failed
Refurbished UNI-ANCHORLOCK®. Replaced Multiweave Paver with Rectangular Paver (8 cm) in DFW Airport Herringbone Pattern, March 1994	satisfactory*	Rectangular Paver Section Failed UNI-ANCHORLOCK® Section Succeeded
Renewed Rectangular Paver in DFW Airport Herringbone Pattern with 90 ° Herringbone Pattern, April 1994	satisfactory*	Rectangular Paver Section Failed UNI-ANCHORLOCK® Section Succeeded (same section as above!)
Restored Rectangular Paver (90 ° Herringbone Pattern). Existing UNI-ANCHORLOCK® and Rectangular sealed with Addiment Sealer, June 1994	satisfactory *all pavers ca.50-70% better than smooth concrete, 20% less than grooved concrete)	Rectangular Paver Section Failed UNI-ANCHORLOCK® Section Succeeded (same section as above!)

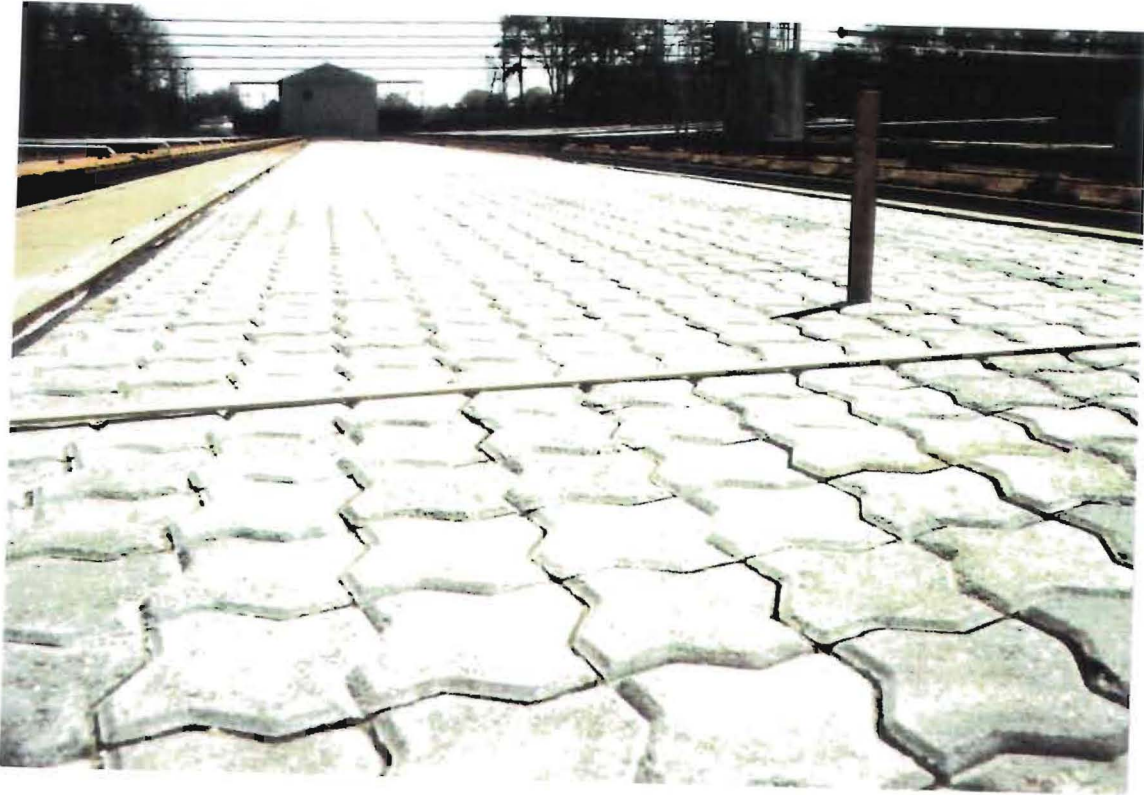
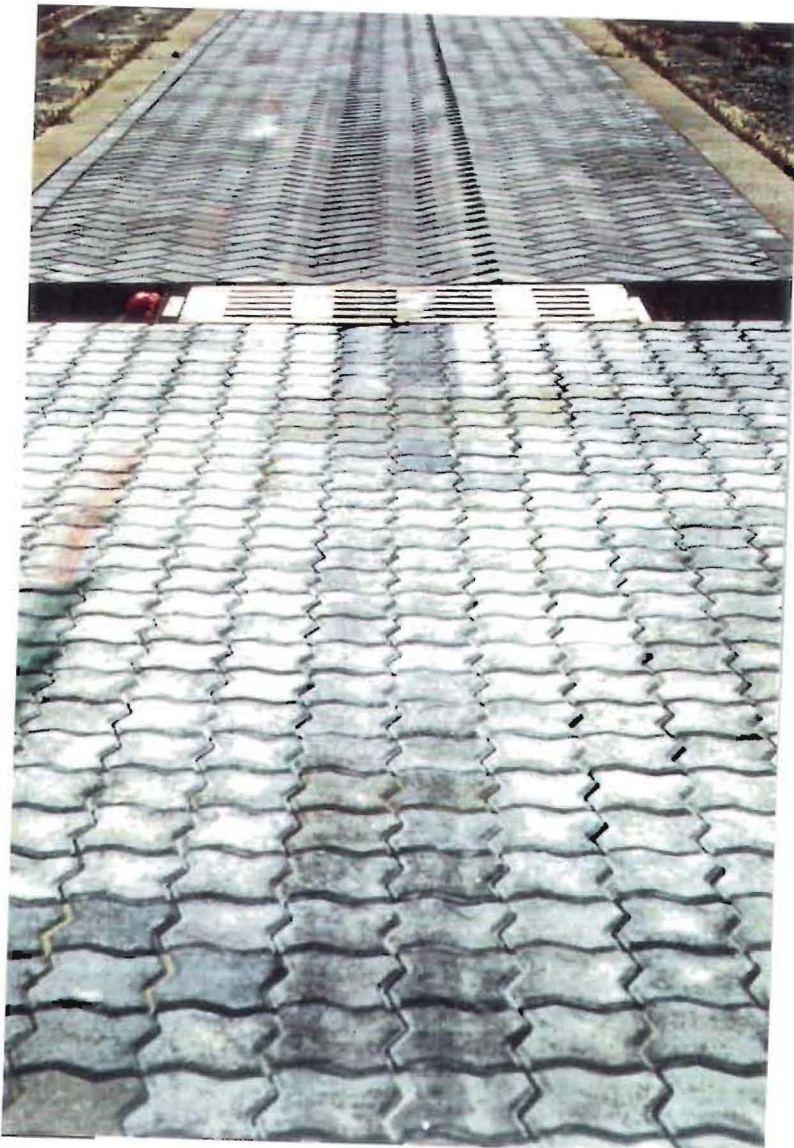
UNI-ANCHORLOCK®
paving stone section,
showing no deformation after
NASA test trial runs,
Spring 94

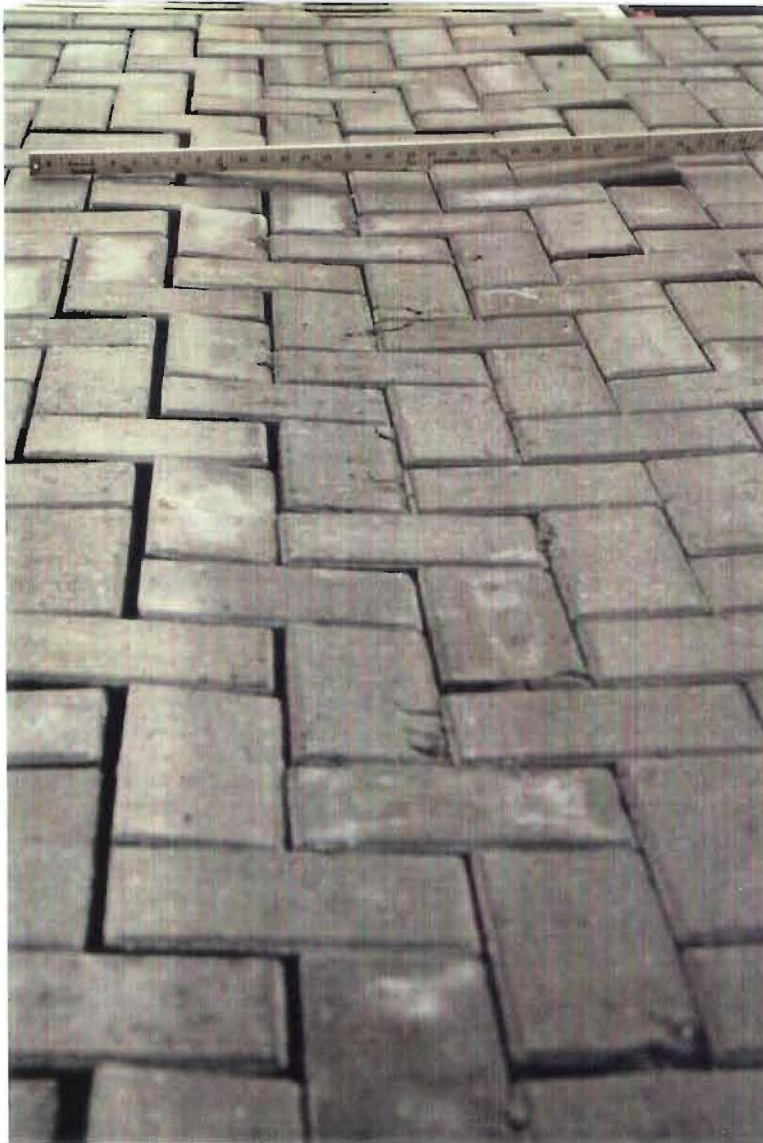
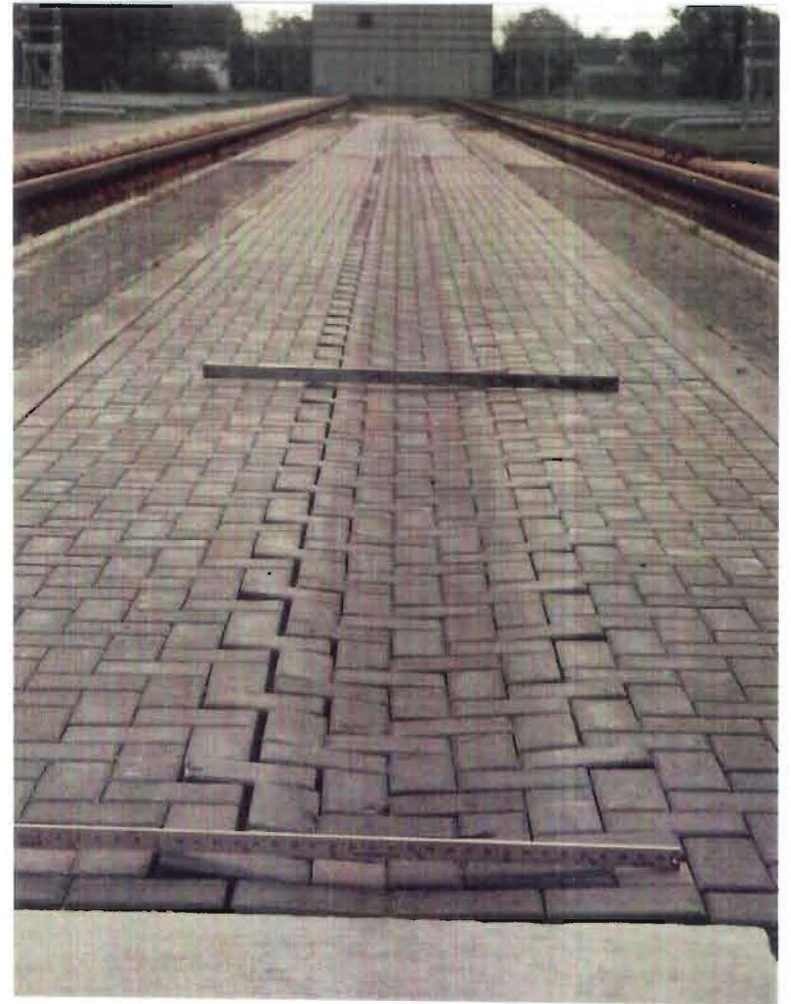
Renewed Rectangular Paving Stone Section (90° Herringbone Pattern), again showing severe deformation, Summer 94
Please note that the UNI-ANCHORLOCK® Section is the same as in the earlier test!
