FINAL REPORT ON A COLD CLIMATE PERMEABLE INTERLOCKING
CONCRETE PAVEMENT TEST FACILITY AT THE
UNIVERSITY OF NEW HAMPSHIRE STORMWATER CENTER

May 2013

**FINAL REPORT ON A COLD CLIMATE PERMEABLE INTERLOCKING CONCRETE
PAVEMENT TEST FACILITY - MAY 2013
BY THE UNIVERSITY OF NEW HAMPSHIRE STORMWATER CENTER**

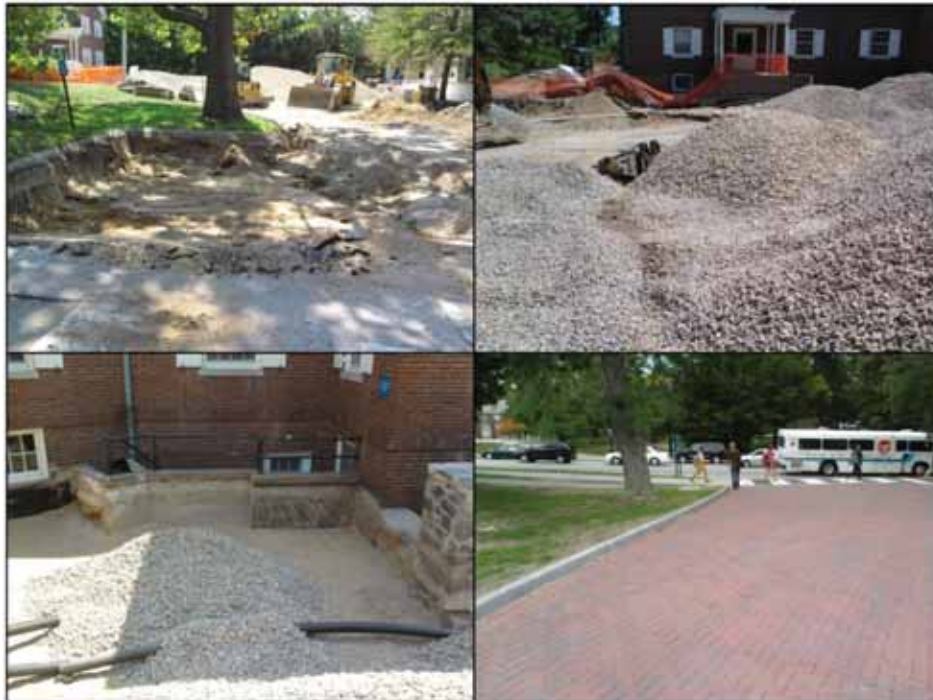
Figure 1: August 2010 installation of PICP system (clockwise from top left) demolition and excavation, placement of subbase aggregate, finished product, underdrain installation.

The UNH test site is a 13,500 square foot PICP system installed in the summer of 2010 on the UNH main campus in Durham, NH (Figure 1, Figure 2). The pre-existing Hood House Drive (7,000 square foot) and J Lot (6,500 square foot) were standard asphalt surfaces. The areas

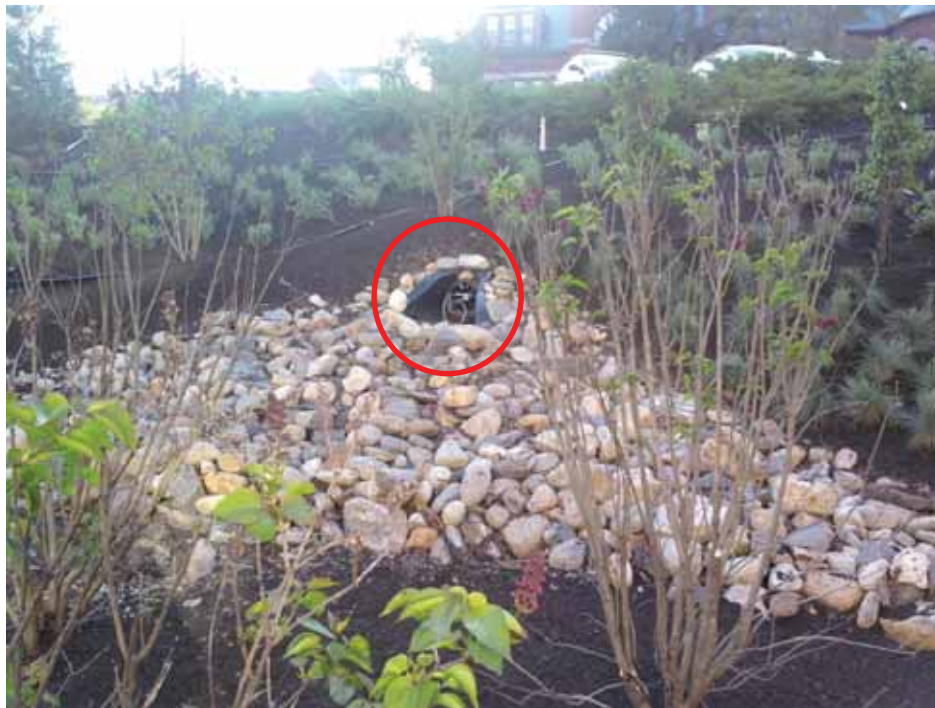
Figure 6: Picture of T Lot effluent location. T Lot is to the upper right in this picture.

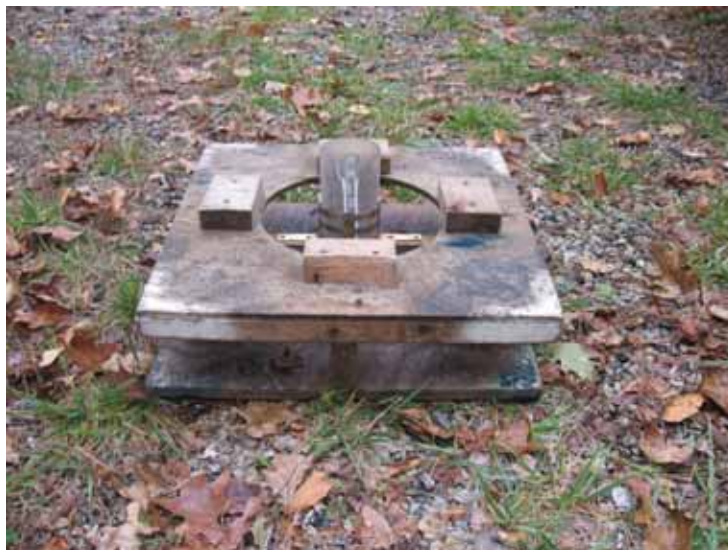
Figure 8: Surface Inundation Test Equipment; A variation on ASTM C 1701 and D 3385-03

Infiltration rate (IR) measurements are developed using a modified surface inundation (SI) device. The modified SI is a falling head test that measures the time to infiltrate a known volume of water (0.56 gallons) through the permeable surface (Figure 8). SI measurements were taken at three separate locations on the PICP lot over 11 times throughout the study. The SI test is a modification of an ASTM Standard D 3385-03 (ASTM, 1988) in which the falling head SI test involves placing a cylinder of known diameter onto the pavement surface which is then sealed to the pavement surface (Briggs, 2006). The UNHSC SI test is similar to ASTM C 1701 for pervious concrete in which both methods measure the infiltration rate of a known volume of water through a pervious pavement. The difference is that the SI is a falling head test that starts time zero when the full volume of water is delivered to the infiltration device. C 1701 specifies that the known volume be delivered to the device at a rate that maintains a surface depth between 10mm to 15mm and starts time zero as soon as water contacts the pavement surface. Another difference is that the SI uses a closed-cell foam foot to seal the cylinder to the pavement surface and C 1701 specifies the use of plumbers putty as a sealant. Also, C 1701 generally requires at least 5 gallons of water to conduct, whereas the modified SI requires 0.56 gallons.

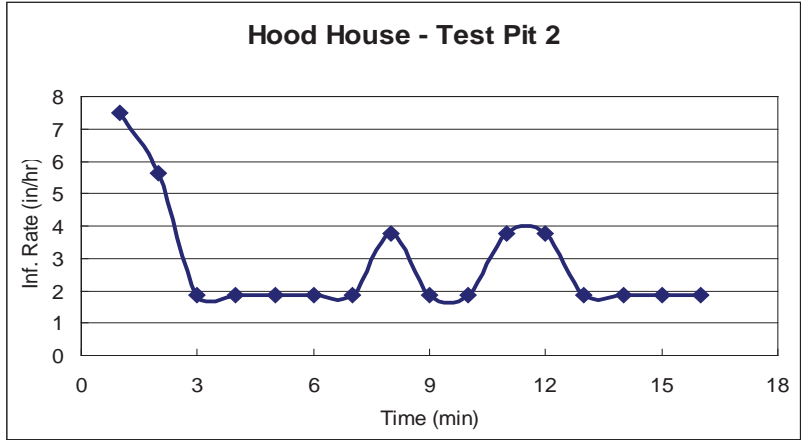
- IC test was conducted using a Turf Tech infiltration device. Results are as follows.
-

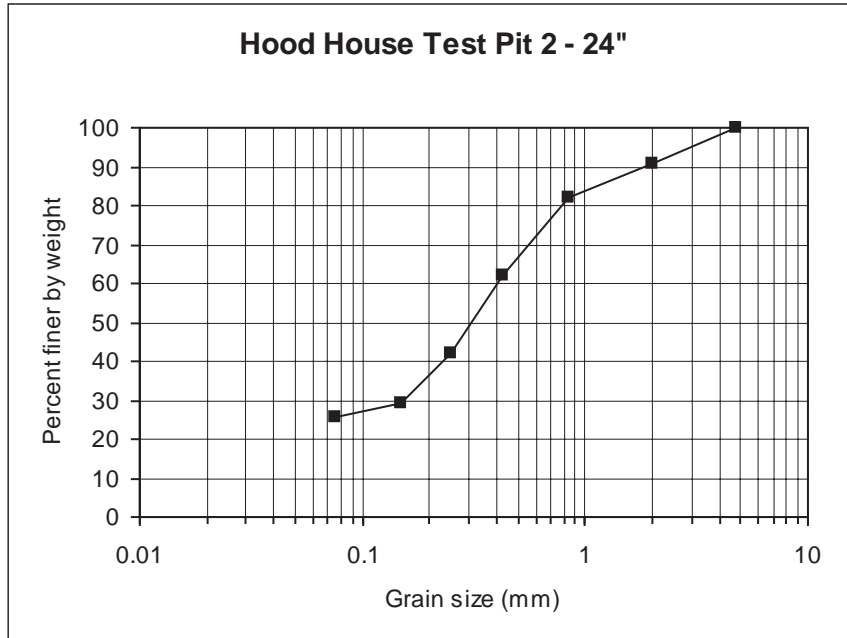
- Soil Sample taken at 24" depth

$D_{10} = < 0.075\text{mm}$
 $D_{30} = 0.160\text{ mm}$
 $D_{50} = 0.300\text{ mm}$
 $D_{60} = 0.400\text{ mm}$

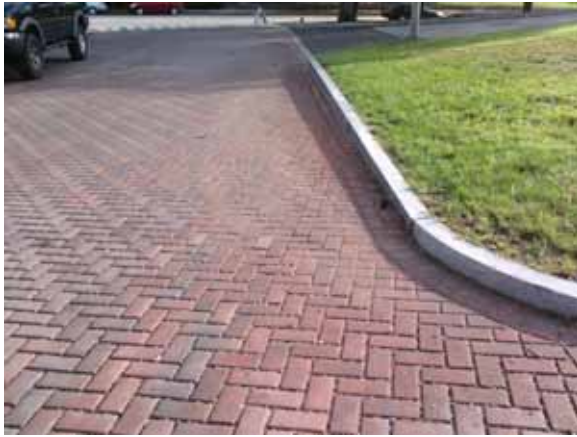
Figure 12: Run on from an intersecting pedestrian walkway.

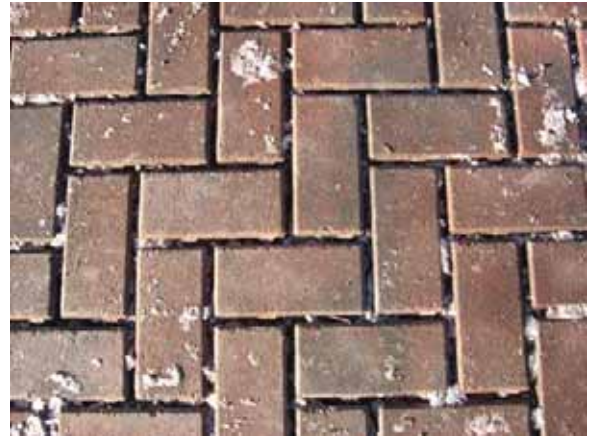
Figure 15: No. 8 joint stone has settled approximately 1 inch.

pavement. It was also evident that many of the pavers were loose and could be wobbled by foot. Winter plowing and freeze-thaw did not dislodge any of the pavers. In August 2011, additional No. 8 joint stone was used to fill in the seams. This proved to stabilize the loose pavers and no further settling was observed through the monitoring period. Photo documentation of various conditions is provided in Appendix E. An operation and maintenance procedure for PICP placements is an area of acute interest for additional research.

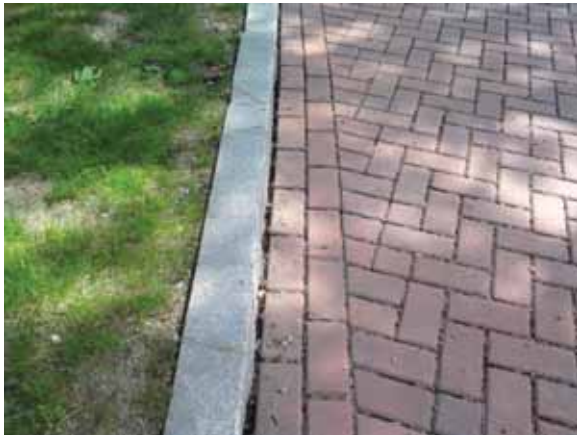
Figure 13: Loss of No. 8 stone along curb line due to erosion and cleaning.

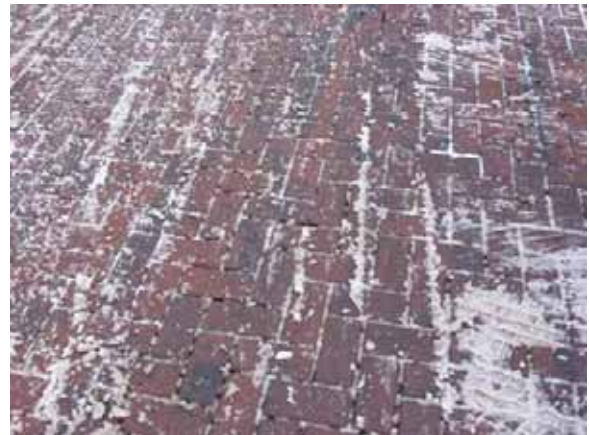
Figure 16: Snow cover after plowing but before sun begins to warm up pavement.

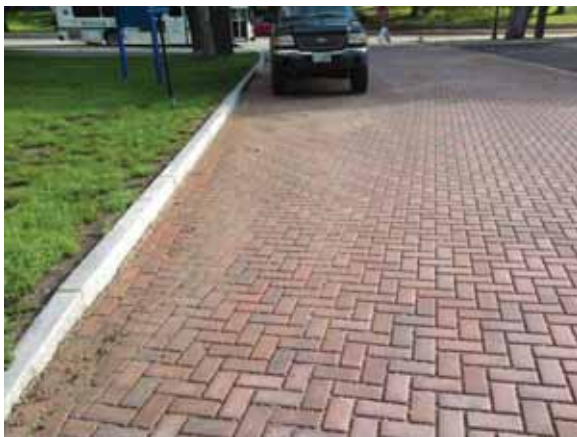
Figure 14: Another area of run on from an intersecting pedestrian walkway.

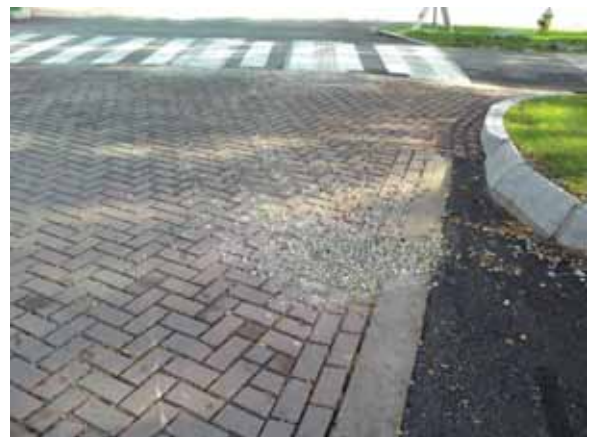
Figure 17: Run on from intersecting MUB drive.
